# Road Quality Analysis on the Simpang Parit Rampak – Simpang PT. Mos Road Section Based on Road Serviceability Assessment Using Star Rating

**Abstract:** This study aims to evaluate the road quality on the Simpang Parit Rampak – Simpang PT. Mos section through a roadworthiness test approach with a star rating. The roadworthiness test is a strategic method in infrastructure maintenance and improvement that assesses the physical aspects, safety, accessibility, and comfort of the road. This road is used for access to the Roro port and for the traffic of Karimun Power Plant (KPP) and PT. Mos employees. This road also connects several areas and is an important route for population mobility and goods distribution. The methodology refers to the Bina Marga approach and incorporates Star Rating-based feasibility testing in accordance with key technical regulations, including Ministry of Public Works Regulation No. 11/PRT/M/2010 on procedures and requirements for road feasibility; Environmental and Road Safety Guidelines No. 06/P/BM/2024 on Technical Instructions for Star Rating-based Feasibility Testing; and Construction Guidelines Pd T-09-2004-B for managing accident-prone locations. The

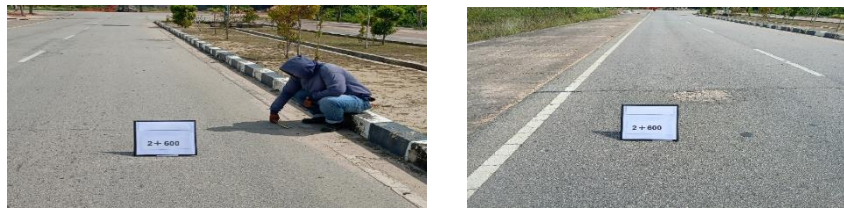
The road damage assessment was conducted on several segments along the road. The recorded damage data show that in the area of STA 2+500 to STA 2+600, the first segment experienced pothole damage and transverse cracking. The next damage was found in the

**Figure 1.** Road Damage Measurement at STA 2+500 – STA 2+600

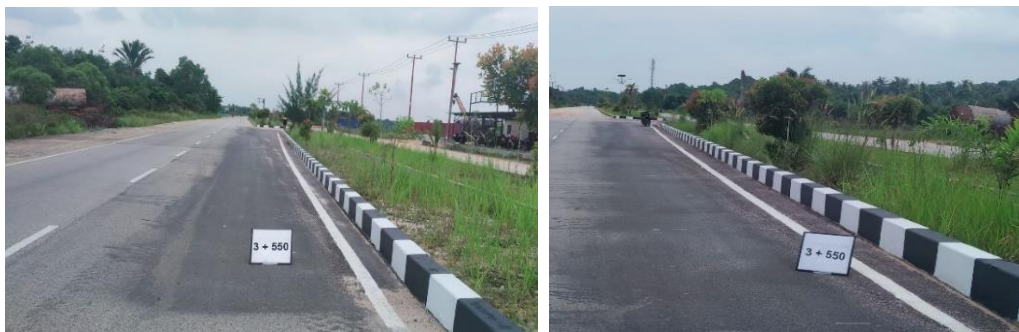
area of STA 3+450 to STA 3+550, where the second segment showed patching damage and longitudinal cracking.

**Figure 3.** Road Damage Measurement at STA 3+450 – STA 3+550

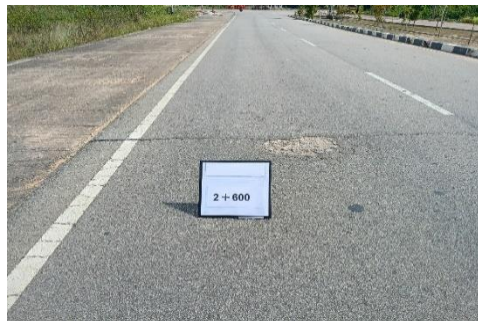
The percentage of damage relative to the road width for transverse cracking at STA 2+500 – STA 2+600 was calculated to be 0.42%. Based on Table 3.2 – Determination of Condition Index Based on Types of Crack Damage, the transverse crack damage value at STA 2+500 – STA 2+600 is  $0.42\% < 10\%$ , corresponding to a Condition Index of 1.

Based on Table 3.2 – Determination of Condition Index Based on Types of Crack Damage, if transverse cracking occurs on the road, the condition index is 3. The width of the transverse crack damage at STA 2+500 – STA 2+600 is 2 cm. Therefore, according to the Table for Determining Condition Index Based on Type of Damage, with a crack width greater than 2 mm, the Condition Index is 3.

**Figure 6.** Transverse Crack Damage Of STA 2+500 - STA 2+600

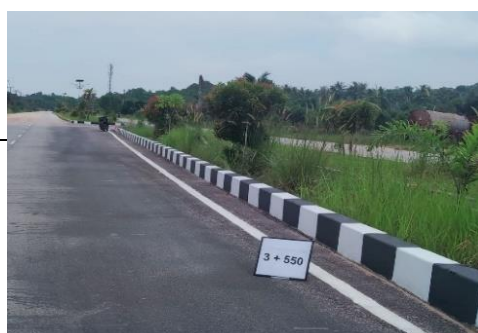
There is patching damage with a length of 100 meters and a width of 2 meters, resulting in a total damaged area of 200 m<sup>2</sup>. The percentage of patching damage to the total segment area at STA 3+450 – STA 3+550 is calculated using Equation 3.3, where the damaged area is divided by the segment area and multiplied by 100, yielding a damage percentage of 28.57%. Based on Table 3.1 – Determination of Condition Index Based on Types of Patching and Pothole Damage, the patching damage value at STA 3+450 – STA 3+550 is 28.57%, which falls within the 20–30% range, corresponding to a Condition Index of 2.

**Figure 7.** Patching Damage On STA 3+450 - STA 3+550

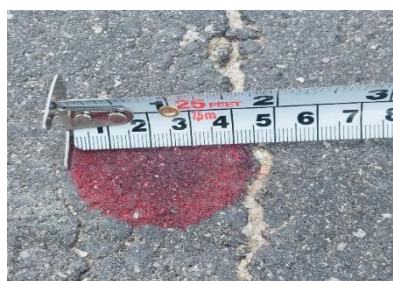
The percentage of damage relative to the road width for longitudinal cracking at STA 3+450 – STA 3+550 was calculated to be 3.57%. Based on Table 3.2 – Determination of Condition Index Based on Types of Crack Damage, the longitudinal crack damage value at STA 3+450 – STA 3+550 is  $3.57\% < 10\%$ , corresponding to a Condition Index of 1.

Based on Table 3.2 – Determination of Condition Index Based on Types of Crack Damage, if longitudinal cracking occurs on the road, the condition index is 2. The width of the longitudinal crack damage at STA 3+550 is 2 mm. Therefore, according to the Table for

Determining Condition Index Based on Type of Damage, with a crack width in the range of 1 mm – 2 mm, the Condition Index is 2.

**Figure 8.** Longitudinal Crack Damage on STA 3+450 - STA 3+550
