# Road Quality Analysis on the Simpang Parit Rampak – Simpang PT. Mos Road Section Based on Road Serviceability Assessment Using Star Rating

**Abstract:** This study aims to evaluate the road quality on the Simpang Parit Rampak – Simpang PT. Mos section through a roadworthiness test approach with a star rating. The roadworthiness test is a strategic method in infrastructure maintenance and improvement that assesses the physical aspects, safety, accessibility, and comfort of the road. This road is used for access to the Roro port and for the traffic of Karimun Power Plant (KPP) and PT. Mos employees. This road also connects several areas and is an important route for population mobility and goods distribution. The methodology refers to the Bina Marga approach and incorporates Star Rating-based feasibility testing in accordance with key technical regulations, including Ministry of Public Works Regulation No. 11/PRT/M/2010 on procedures and requirements for road feasibility; Environmental and Road Safety Guidelines No. 06/P/BM/2024 on Technical Instructions for Star Rating-based Feasibility Testing; and Construction Guidelines Pd T-09-2004-B for managing accident-prone locations. The

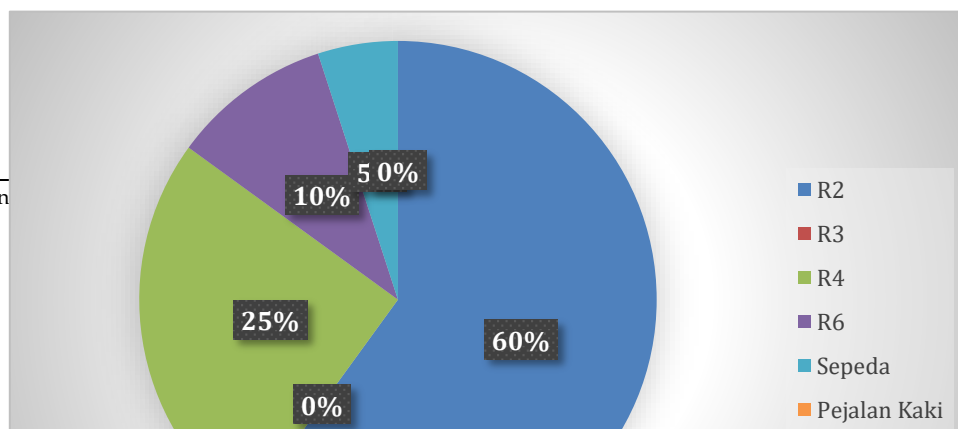
**Gambar 11.** Persentase Pihak Terlibat Kecelakaan

The assessment results show that the percentage of road users involved in accidents is as follows: 2-wheeled vehicles 60%, 3-wheeled vehicles 0%, 4-wheeled vehicles 25%, 6-wheeled vehicles 10%, bicycles 5%, and pedestrians 0%. Based on these results, it can be concluded that the road users most frequently involved in accidents are 2-wheeled vehicles (motorcycles), with a percentage of 60%.

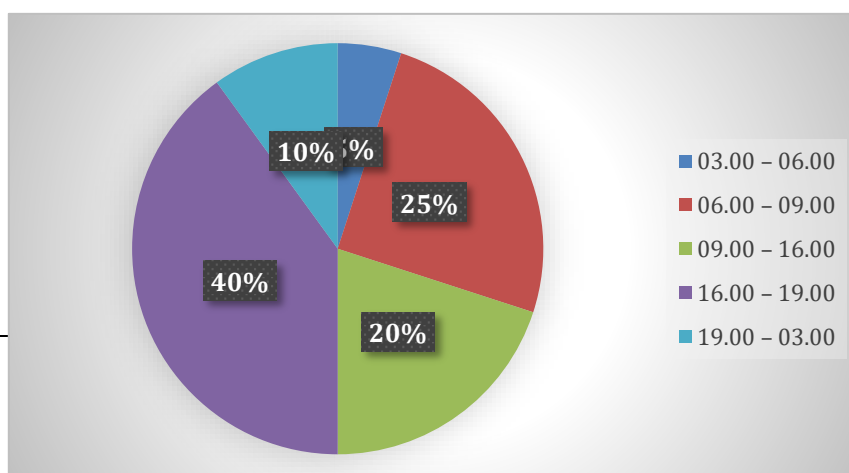
**Figure 12.** Persentase Waktu Terjadinya Kecelakaan

Based on the assessment results, the percentage of accidents by time period is as follows: 03:00–06:00 at 5%, 06:00–09:00 at 25%, 09:00–16:00 at 20%, 16:00–19:00 at 40%, and 19:00–03:00 at 10%. From these results, it can be concluded that the time period with the highest number of accidents is 16:00–19:00, with 8 incidents or 40%.

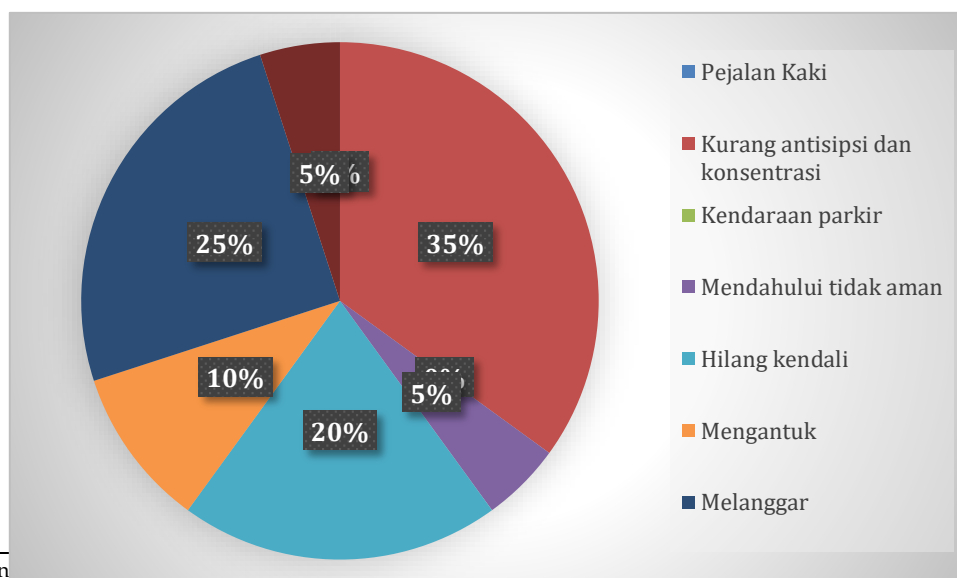
**Figure 13.** Persentase penyebab kecelakaan

Based on the assessment results, the leading cause of accidents is due to a lack of anticipation and concentration, with a percentage of 35%.

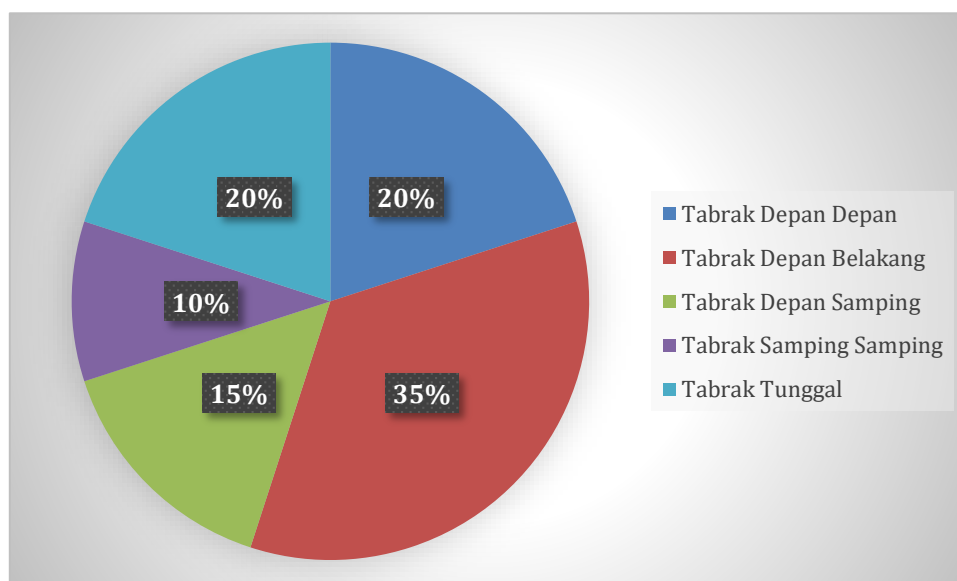
**Figure 14.** Persentase Tipe Tabrakan

Based on the assessment results, the most frequent type of accident on the Simpang Parit Rampak – Simpang PT. Mos road is rear-end collisions, with a total of 7 incidents or 35%.

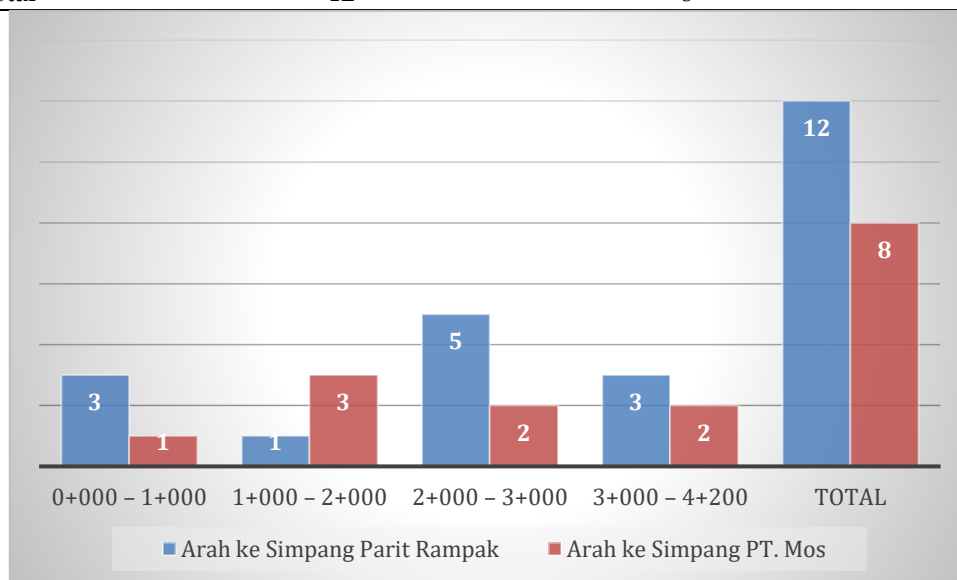
**Figure 15.** Bar Chart Accident Location

The location with the highest accident frequency occurred at STA 2+000–3+000, in the direction of the Parit Rampak intersection.

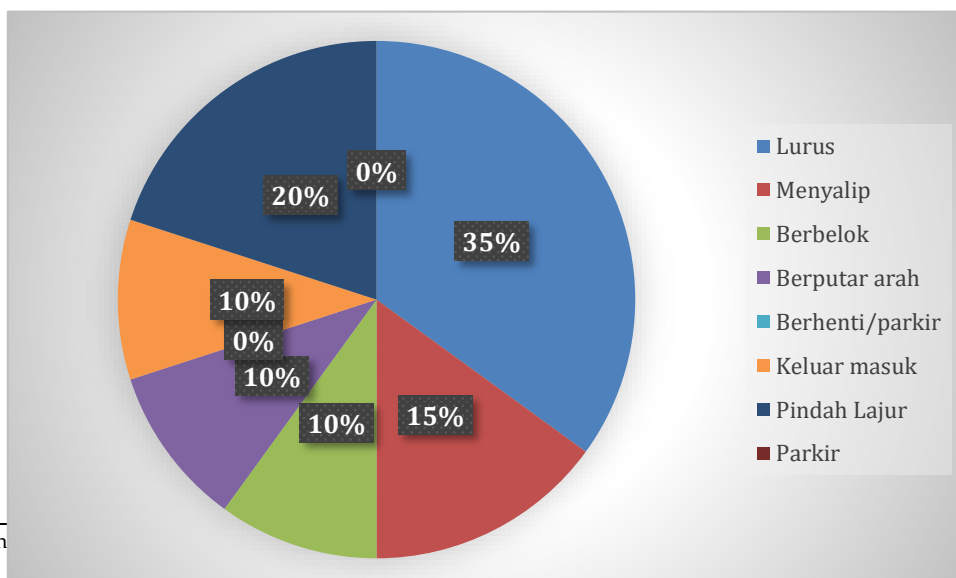
**Figure 16.** Percentage Of Vehicle Manuevers

From the assessment results, it was found that the vehicle maneuver most frequently involved in accidents was vehicles moving straight, with a total of 7 cases, accounting for 35%.
