Road Damage Analysis Using the Bina Marga Method (Case Study of the Parit 5 Tembilahan Hulu Road Section)

Ade Andriani*, Deddy Purnomo Retno, Elizar

Universitas Islam Riau

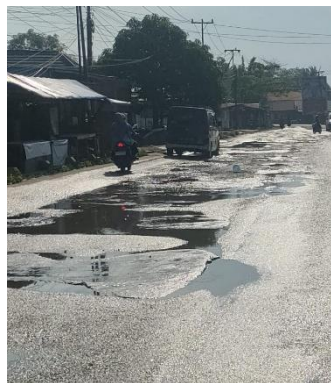
Figure 1. Road Column

The Parit 5 Road section is one of the main connecting roads in Tembilahan Hulu District, Indragiri Hilir Regency, Riau Province. This road has an important role in community mobility and distribution of agricultural and plantation products, especially coconut and areca nut which are the region's leading commodities. The length of the Jalan Parit 5 section that is the object of this study is 800 meters (0.80 km), which begins at the coordinates (0°23'14.57"N, 100°50'40.57"E) – as STA 0+000 and ends at the coordinate point (0°25'26.99"N, 100°48'50.82"E) – STA 0+800. Jalan Parit 5 is a road with 1 lane of 2 lanes as shown in Figure 5.1, where the road body consists of a layer of flexible pavement and concrete road shoulders, with a road body size of 4.00 meters and the left and right road shoulders of 1.00 meters each.
